Statistical Analysis of Electrical Component Aging in Group 6 of the Inga 2 Hydroelectric Plant Following Abrupt Shutdowns

Keywords: Inga 2 hydroelectric power plant, turbine-generator group 6, stator and rotor winding resistances, predictive maintenance

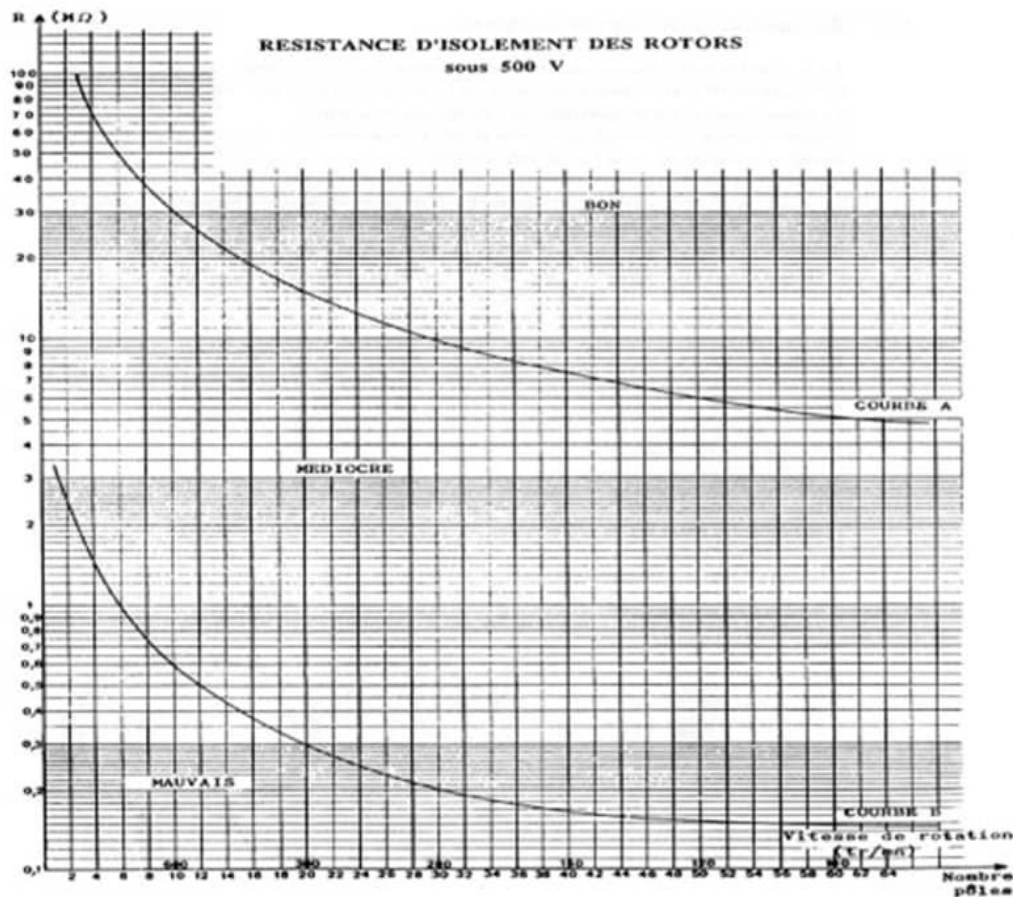
Figure 4. Insulation resistance graph of rotors under 500V [2]

We analyzed the rotor insulation resistances at 500 volts, as shown in Figure 4. This graph shows three distinct zones that reflect the condition of the rotor insulation. The first zone, called “good,” corresponds to insulation resistance values greater than 10 MΩ. This indicates that the rotor insulation is in good condition, providing adequate protection against current leakage. The second zone is called “average” and encompasses resistance values between 2 and 10 MΩ. When the insulation resistance falls within this range, it means that the condition of the rotor insulation is acceptable, but careful monitoring is required to prevent future degradation. Finally, the last zone, called “poor,” includes values less than 2 MΩ. An insulation resistance in this category indicates significant deterioration of the rotor insulation, requiring immediate corrective action to avoid potential short-circuit or system failure risks. These observations, based on the data presented in Figure 4, highlight the importance of regularly monitoring insulation resistance to ensure rotor safety and efficiency.

For the rotor insulation resistances reduced to 20° calculated by expression (3), we have retained the largest, which was taken at 10 minutes and is worth 5 M Ω corresponding to 56 poles or 107.1 rpm of the operating curves (Figure 4) which is in the mediocre zone.
